**Thru Tubing Solutions' Abrasive Cutting System Performs Cut on Damaged 5.50" OD Casing, Creating a Cost Effective Solution to a Normally Very Costly Dilemma.**

**Location:** Pecos County, TX

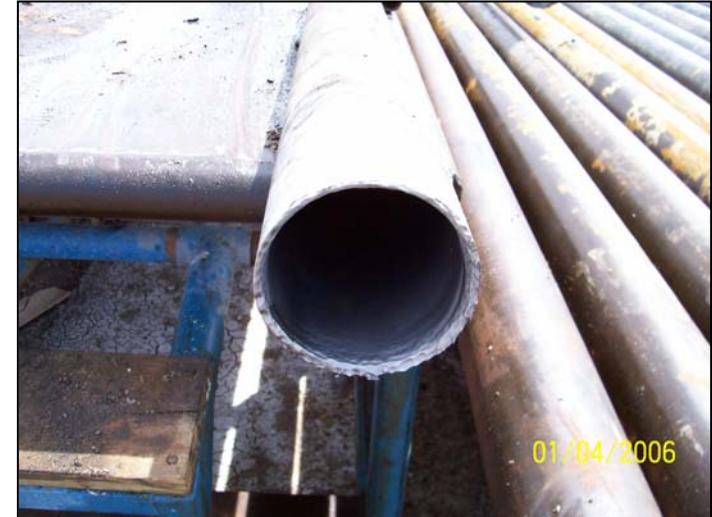
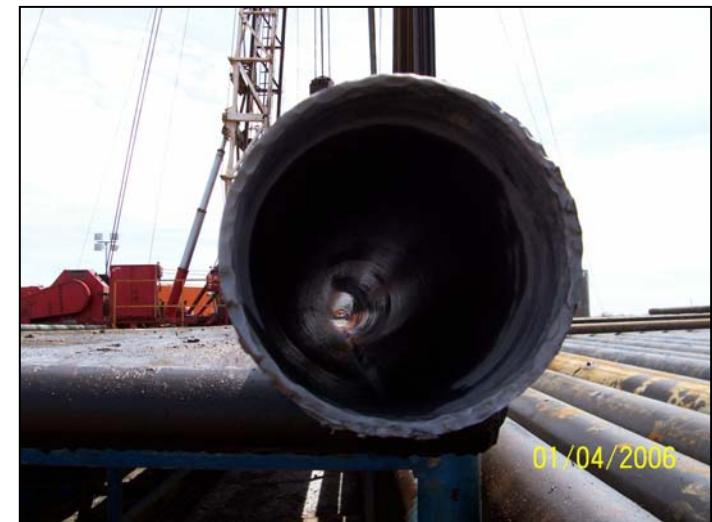
To cut 5.50" OD, 17# casing that had become shattered during a frac stimulation.

In 40 minutes pumping at 1 BPM the casing had been completely cut, allowing rig to pull casing out of the hole and latch back onto lower section of casing with new casing.

Damaged casing was cleanly removed. This expedited the re-completion of the well, avoiding costly and lengthy fishing of the damaged casing.
